This safety alert is drawn up to spread the lessons learnt from the major oil release of October 25th, 2005 in an oil storage terminal. The oil storage terminal belongs to a large oil company and is an upper tier Seveso establishment.

## 1. Description of the oil storage terminal

## 4. Causes of the tank rupture

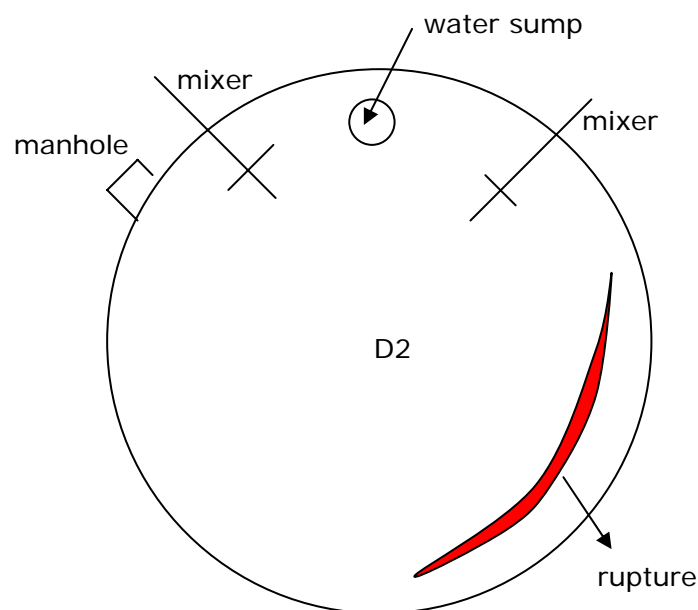
Figure 5 : Schematic view of the bottom of storage tank D2

The investigation of tank D2 showed that the bottom plates in a long, small circular band at approximately 1,5 m from the shell of the storage tank were extremely weakened due to internal corrosion. In this band the thickness of the bottom plates was nearly reduced to zero. This band had a length of approximately 35 m and a width of approximately 20 cm.

In this band the bottom of the tank formed a gutter. In this gutter uniform, internal corrosion was found and no pitting corrosion.

The bottom plates showed no external corrosion in the long, small band. The other bottom plates indicated no extreme corrosion.

During the exploitation of storage tank D2 a gutter was formed in the bottom of the tank. This gutter is situated at a distance of 1,5 m from the tank shell. Due to the formation of the gutter the present water could not longer flow to the drain water system to be removed. The accumulation of stagnant water in the gutter caused strong corrosion which strongly reduced the thickness of the bottom plates in that area.

The major release initially started with a small leak. Due to this small leak the compacted sand underneath the tank bottom was saturated with oil and a kind of quicksand of oil and sand is formed. This small leak has not been visually detected because the crushed rock annular ring had a lot of holes, which were initially filled with crude oil. In the second phase of the accident the resistance of the foundation under the tank was locally strongly reduced (due to the fluidisation of the sand bed) and due to the hydrostatic pressure of the crude oil on the tank bottom, the bottom has ruptured over the length of the gutter. The force of the out flowing crude oil was that large that it destroyed a part of the tank foundation and swept away part of the underground.

In the gutter in the bottom of the tank, the present water could not longer flow towards the water sump. This situation of stagnant water in the gutter enabled very fast corrosion in the gutter with the rupture of the tank bottom as the major consequence.

The parts of the bottom plates of the other storage tanks of which the thickness and/or the deformation do not fulfil the prescriptions of API 653 shall be repaired. The foundation of the other storage tanks was investigated to control if they still have enough stability (during the accident they were drawn in crude oil) to restart the exploitation of the storage tanks.

Before start-up all crude oil storage tanks shall be coated with a lining to stop the internal corrosion of the bottom plates.

The company also decided to adjust the inspection program of all vertical storage tanks. Between two internal inspections acoustic emission measurements will be performed. Based on the results of these acoustic emission measurements, the next date for the internal inspection shall be adapted if necessary. During the internal inspection of the storage tanks the condition of the bottom of the tank is visually inspected. From the moment there is any doubt about the condition of the bottom plates, ultrasonic thickness measurements will no longer be performed in a cross banded pattern, but the whole bottom of the storage tank will be fully scanned. If a floor scan is performed, 5 additional ultrasonic thickness measurements will be carried out on each bottom plate.

In order to detect leaks in an early stage the company has decided to install a detection with alarm on abnormal level changes on crude oil tanks. Such systems were already available on product tanks in the refinery. Besides these measurements the company is still evaluating to install an on-line oil detection system under the storage tanks.
